GROWMARK, INC.

PRESSURE VESSEL TEST AND INSPECTION REPORT - MC330/331 TRANSPORT

Heartland Coop 8513

**INSPECTION & REPAIR REPORT FORM FOR MC-330, 331 CARGO TANKS
INSPECTED BY THE SET FLUORESCENT MAGNETIC PARTICLE METHOD**

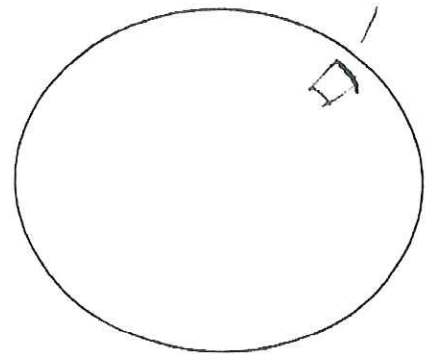
REAR HEAD

Cracks in
Flush Patch

FAILED REPORT UNIT NOT REPAIRED

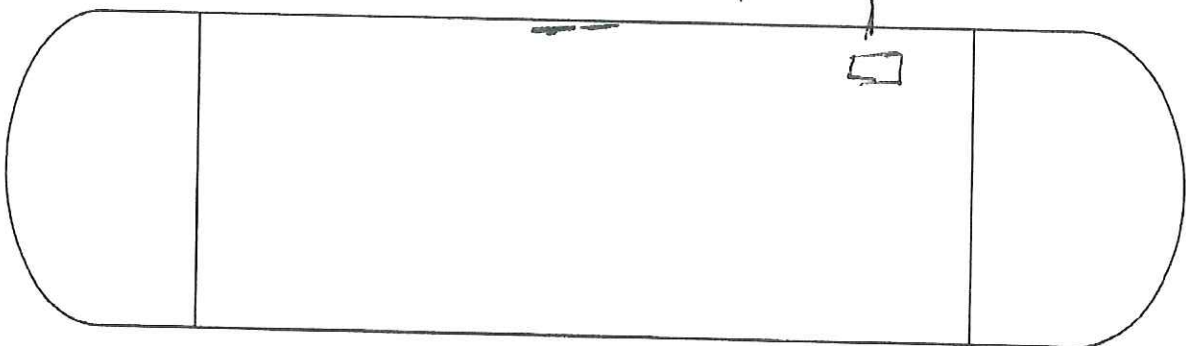
RIGHT SIDE

Cracks in Flush Patches
